INDOOR AIR QUALITY ASSESSMENT

**Penn Brook Elementary School
68 Elm Street
Georgetown, Massachusetts**

Prepared by:
Massachusetts Department of Public Health
Bureau of Environmental Health Assessment
April, 2002

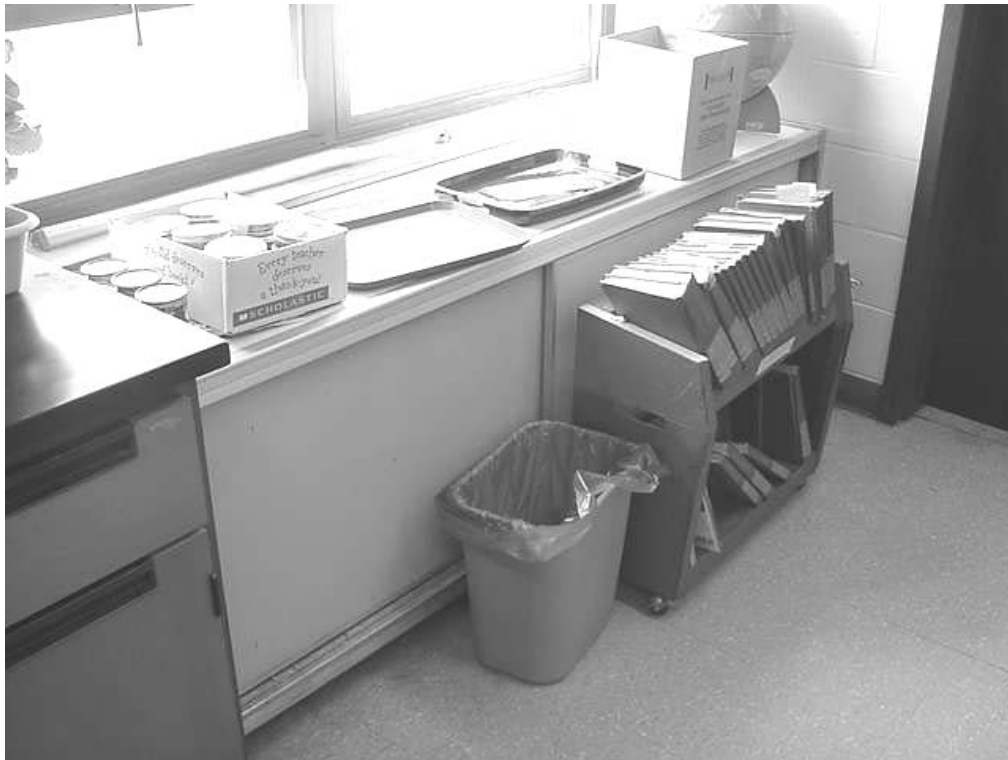
Picture 1

Fresh air in classrooms is supplied by a unit ventilator (univent) system (see Picture 1). Univents draw air from outdoors through a fresh air intake located on the exterior walls of the building (see Picture 2) and return air through an air intake located at the base of each unit ([see Figure 1](#)). Fresh air and return air are mixed, filtered, heated and provided to classrooms through a fresh air diffuser located in the top of the unit. Univents were found deactivated in a number of classrooms (see Tables/Picture 3). Obstructions to airflow, such as books, papers, and desks were seen in a number of classrooms (see Pictures 1 & 4). In order for univents to provide fresh air as designed, they must remain free of obstructions. Importantly, these units must be activated and allowed to operate.

Classroom Univent: Note Items on Top and In Front of Unit, Obstructing Airflow

3. Consider having the ventilation system balanced by an HVAC engineer every five years (SMACNA, 1994).
4. Remove all blockages from univents to ensure adequate airflow. Clean out interiors of univents regularly.

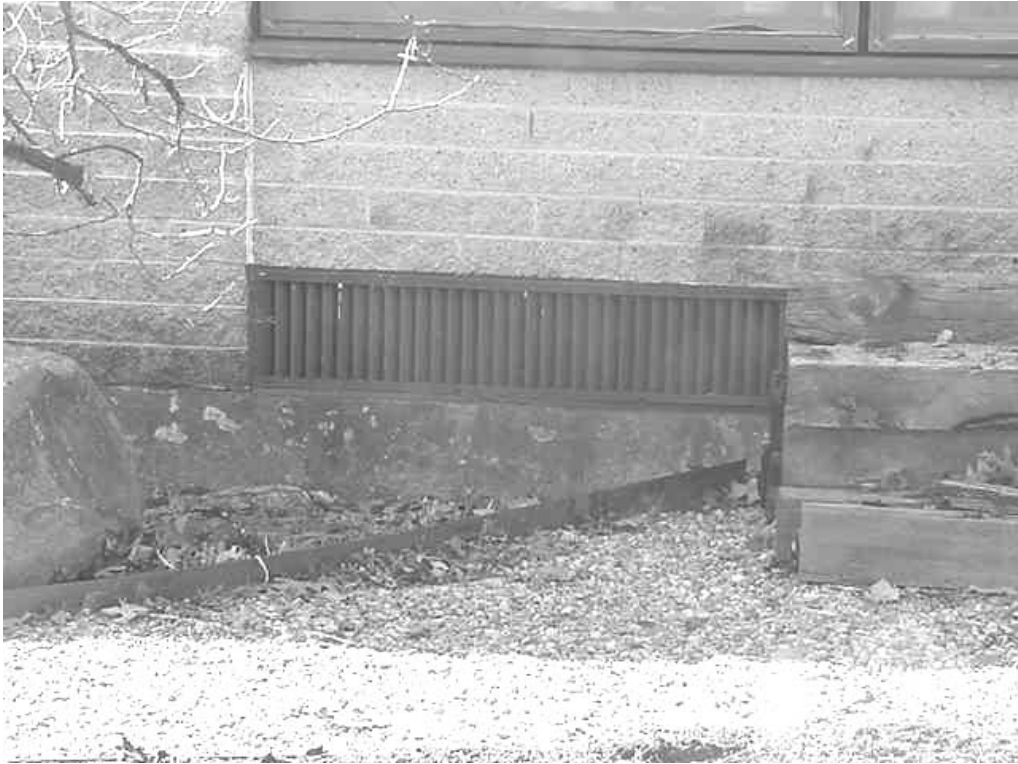
Picture 2

Univent Fresh Air Intake

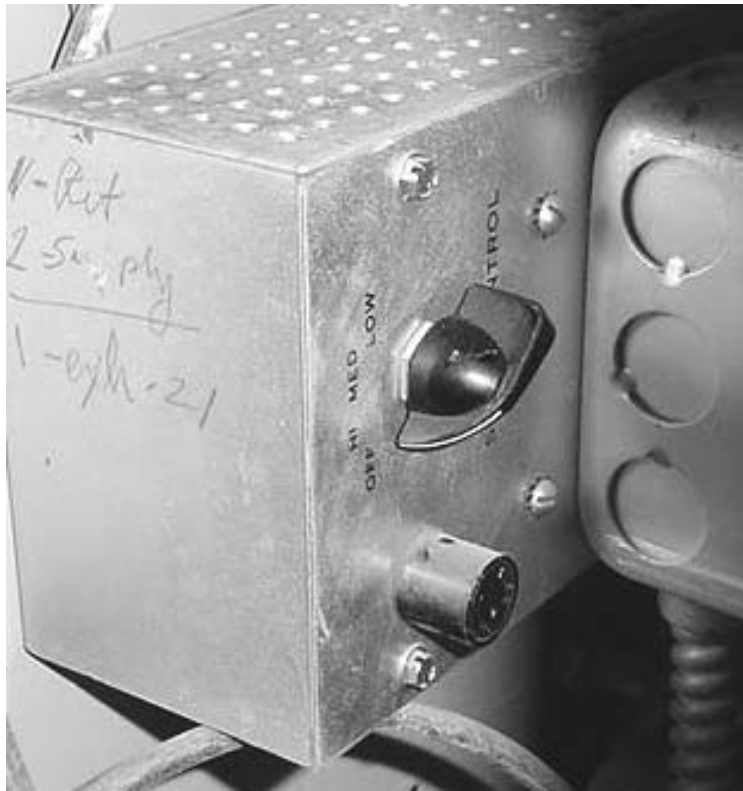
Picture 3

Univent Control Switched to Off Position in Classroom During School Occupancy

1. Develop a clear line of communication between the maintenance department and school personnel for prompt remediation of temperature and/or ventilation concerns/complaints. This can be done by establishing a written request system administered by a single responsible person. Classroom occupants should report temperature extremes immediately to school administration/maintenance and refrain from deactivating equipment.
2. To maximize air exchange, the BEHA recommends that both supply and exhaust ventilation *operate continuously* during periods of school occupancy independent of classroom thermostat control.

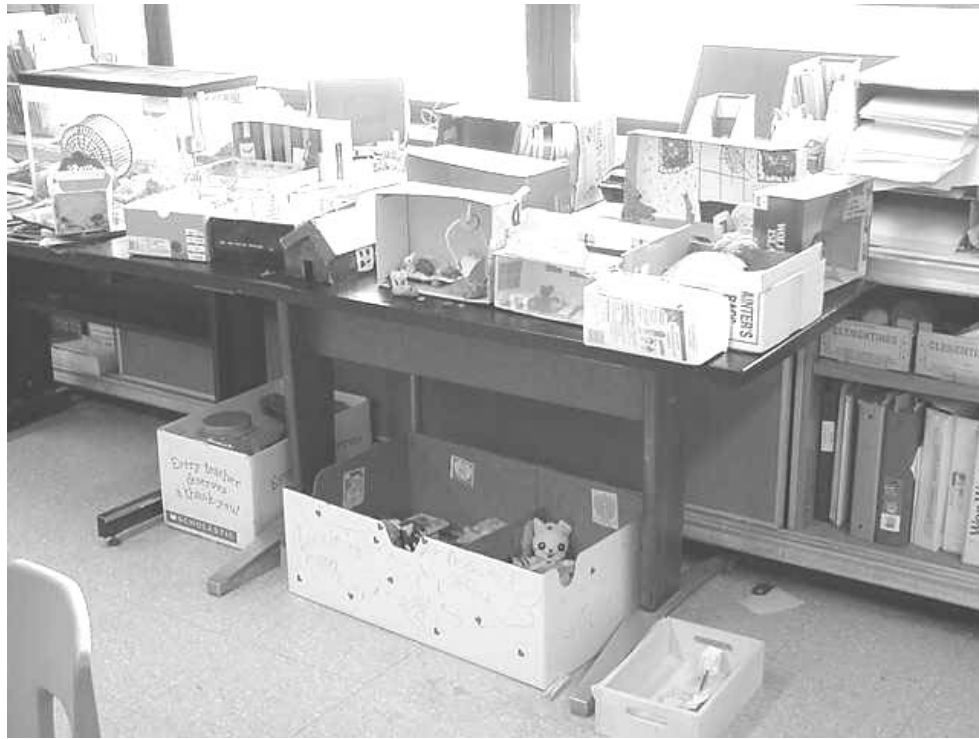
Picture 4

Univent Obstructed by Various Items

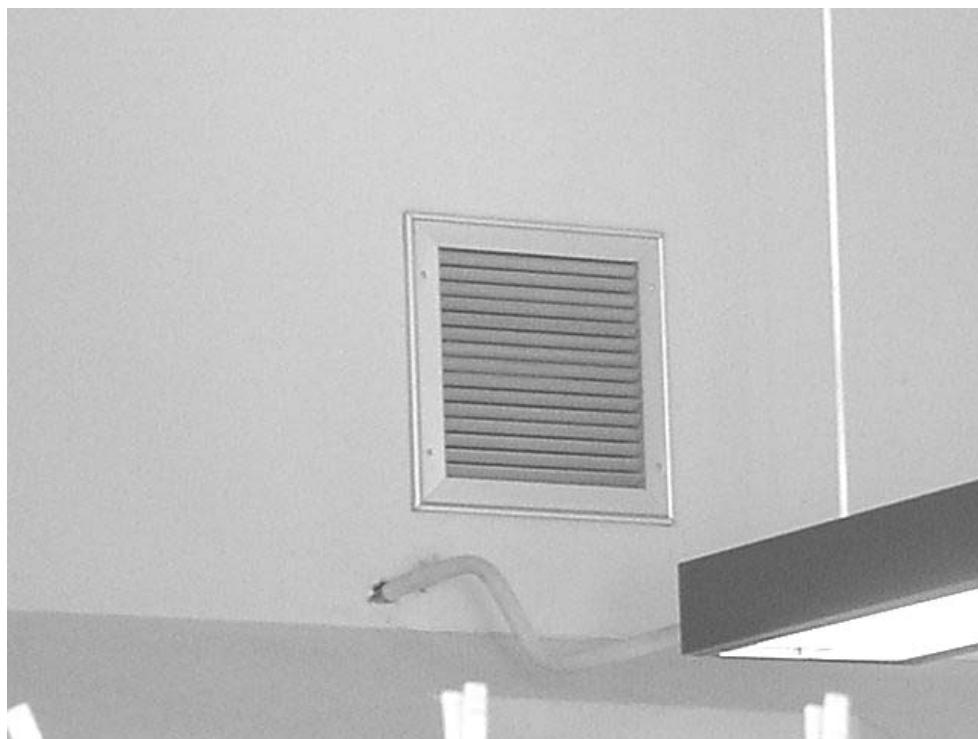
Picture 5

The mechanical exhaust ventilation system in classrooms consists of grated, wall-mounted exhaust vents (see Picture 5). Exhaust vents from individual classrooms are drawn into a common duct above the ceiling in hallways to be expelled from the building

Wall-Mounted Exhaust Vent in Classroom

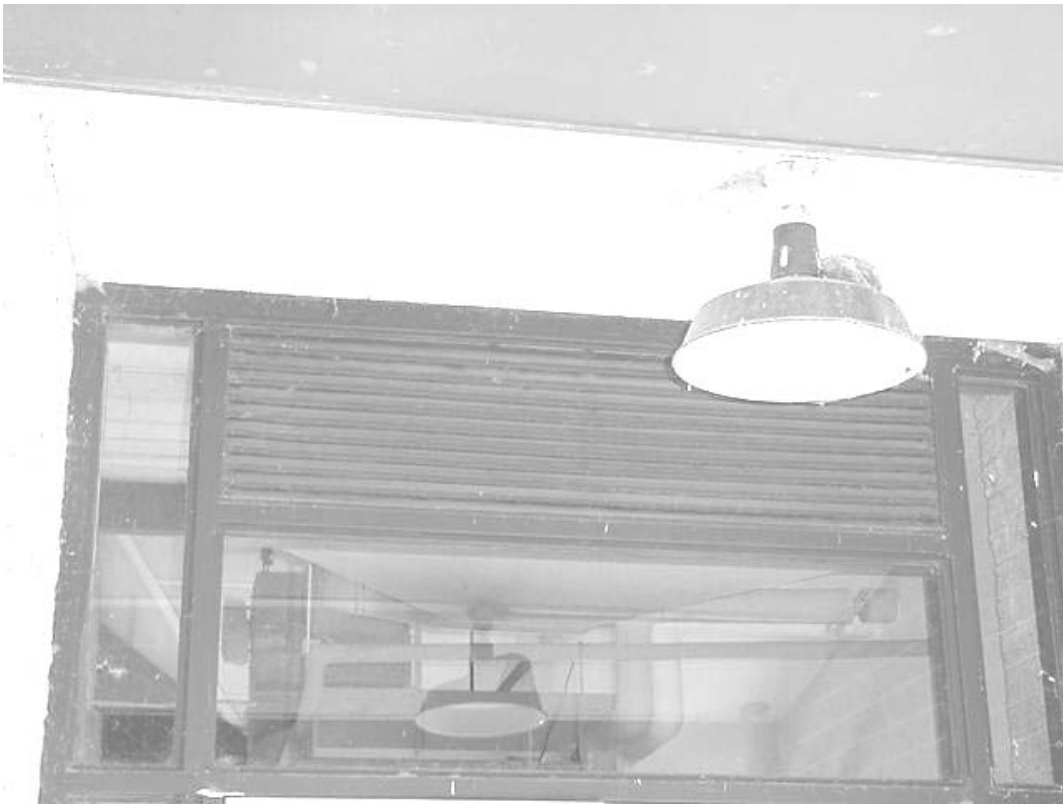
Picture 6

via an exhaust grill at the terminus of each hallway (see Picture 6). At the time of the assessment a number of exhaust vents were not operating (see Tables), which can indicate that they were deactivated or were mechanically malfunctioning (e.g. motor burnt out, broken belt).

Exhaust System Terminus above Exterior Door

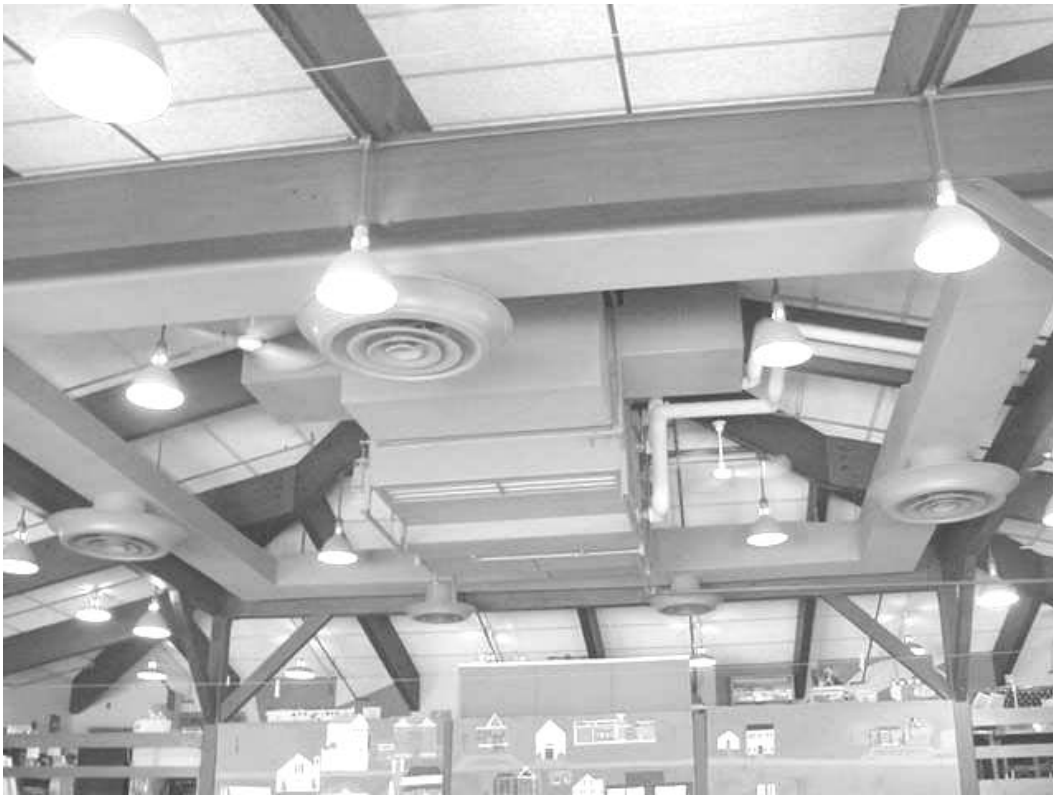
Picture 7

Ventilation in the gymnasium, library-media center and cafeteria is provided by ceiling mounted air handling units (AHUs) (see Picture 7). Fresh air is distributed via ductwork connected to ceiling-mounted air diffusers. The amount of fresh air drawn into the units is controlled by moveable louvers connected to an activator motor that adjusts to alter fresh air intake to maintain temperature. School maintenance staff reported that the AHUs for the gymnasium and library are seldom used.

Ceiling-Mounted AHU and Air Diffusers for Library-Media Center

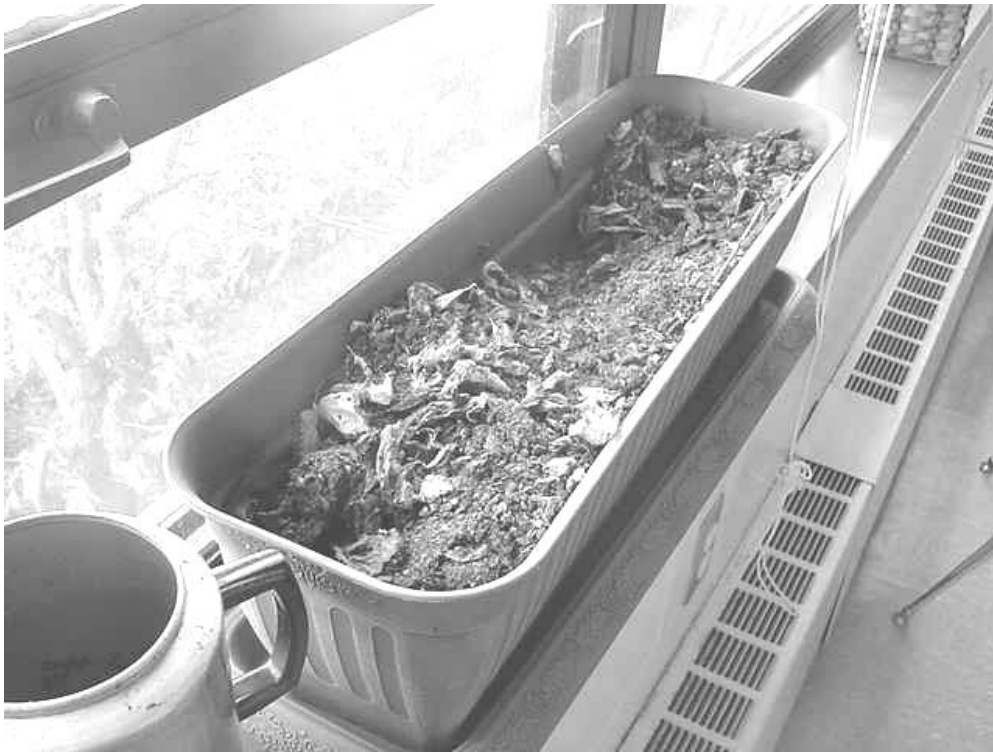
Picture 8

Several classrooms had a number of plants. Moistened plant soil and drip pans can be a source of mold growth. A window planter with decaying plant matter and old potting soil was seen on the windowsill in the teacher's lounge (see Picture 8).

Window Planter with Decaying Plant Matter and Potting Soil in Teacher's Lounge

6. Remove plants from univents. Ensure plants have drip pans. Examine drip pans periodically for mold growth and disinfect with an appropriate antimicrobial where necessary. Discard decaying plant matter and potting soil in teacher's lounge.

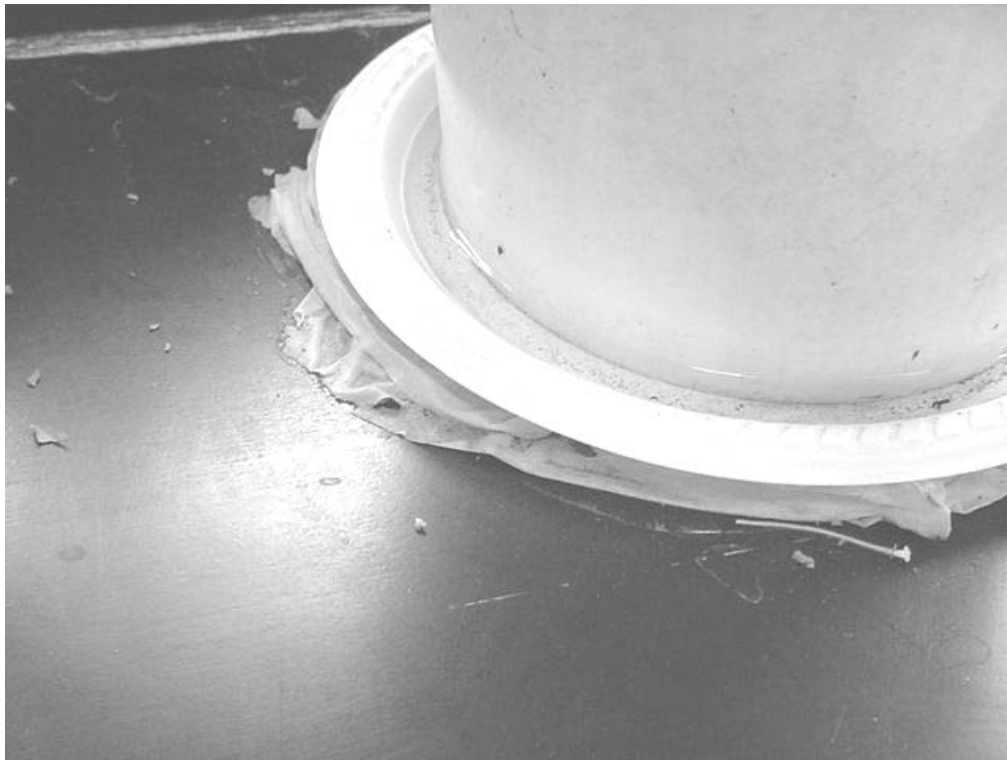
Picture 9

Classroom 24 had plants on paper plates on top of paper towels that were saturated with water (see Picture 9). Plants should be equipped with drip pans. Paper plates and towels are porous materials that can be colonized by microbial growth, especially if wetted repeatedly. In addition, the lack of drip pans can lead to water pooling and mold growth on windowsills. Plants are also a source of pollen. Plants in several classrooms were noted near univent air diffusers (see Picture 10). Plants should be located away from the air stream of ventilation sources to prevent the aerosolization of mold, pollen or particulate matter throughout the classroom.

Plant on Wet Paper Towels and Paper Plate with Standing Water in Classroom

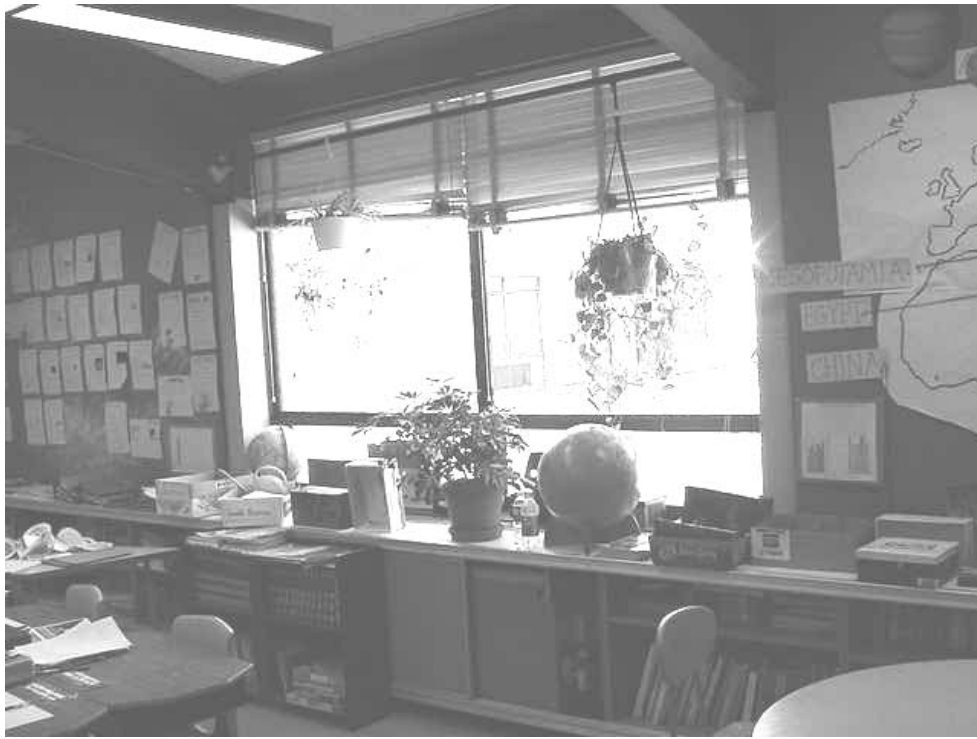
Picture 10

Plants on and above Classroom Univent Air Diffusers

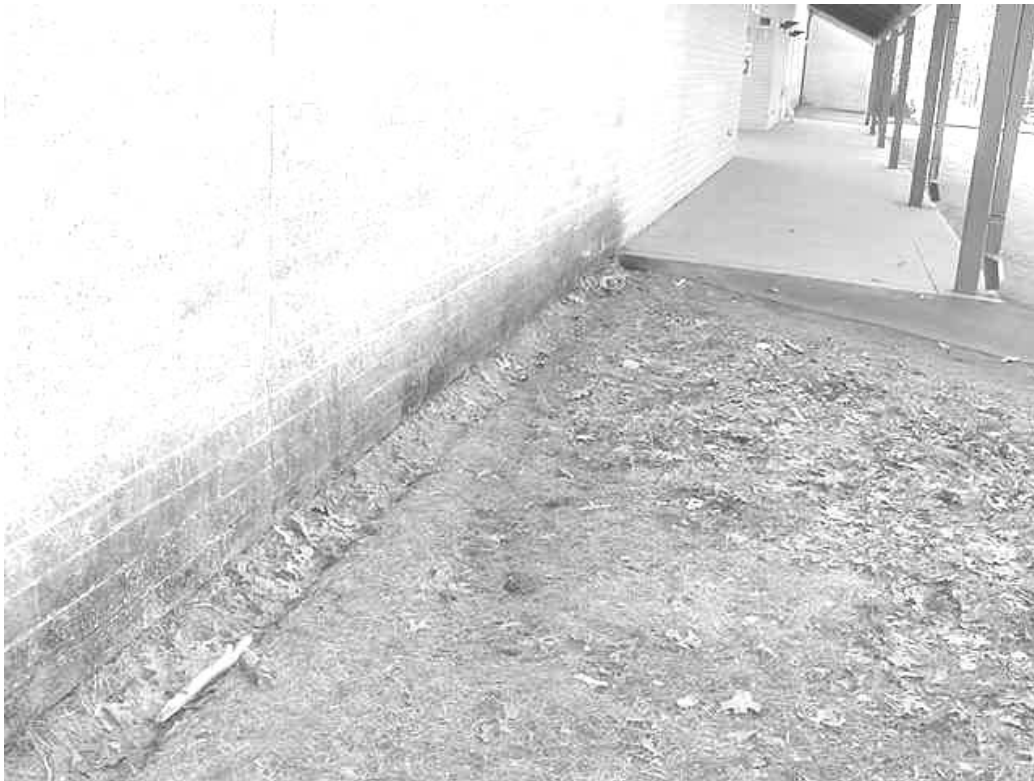
Picture 11

The absence of a gutter/downspout system along the roof eave to direct rainwater away from the base of the exterior walls (gutters are only installed over exterior doors) was noted. After rainstorms, the exterior walls are saturated with moisture. Rainwater runs off the roof onto the ground at the base of the building. This runoff has created a trench parallel to the base of the wall, which allows rainwater and melting snow to pool against the foundation and the exterior wall of this wing. Splashing water along the edge of the building wets the base of exterior walls creating a characteristic stain (see Picture 11). Growth of moss on exterior brickwork (see Picture 12) is another indication of chronic moisture exposure from rainwater. Moss growth also holds moisture against brickwork. North-facing corners and walls of this building are particularly vulnerable to moisture for extended periods of time, since the brick is not dried out by exposure to direct sunlight. Excessive exposure to water of exterior brickwork can result in damage over time. During winter weather, the freezing and thawing of moisture in bricks can accelerate the deterioration of brickwork. Exacerbating moistening of exterior brickwork

Trench and Wall Staining alongside Front of Building

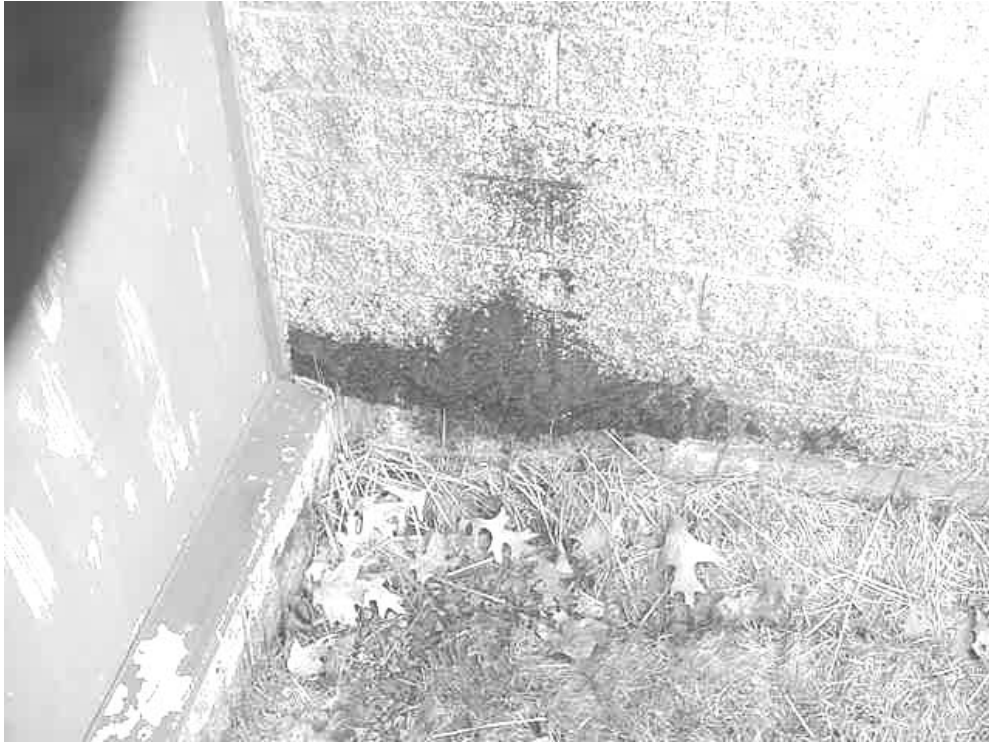
Picture 12

Moss Growth on Exterior Wall

7. Remove plant growths against the exterior wall/foundation of the building to prevent water penetration.
8. Clean exterior walls and univent air intakes of moss and debris.

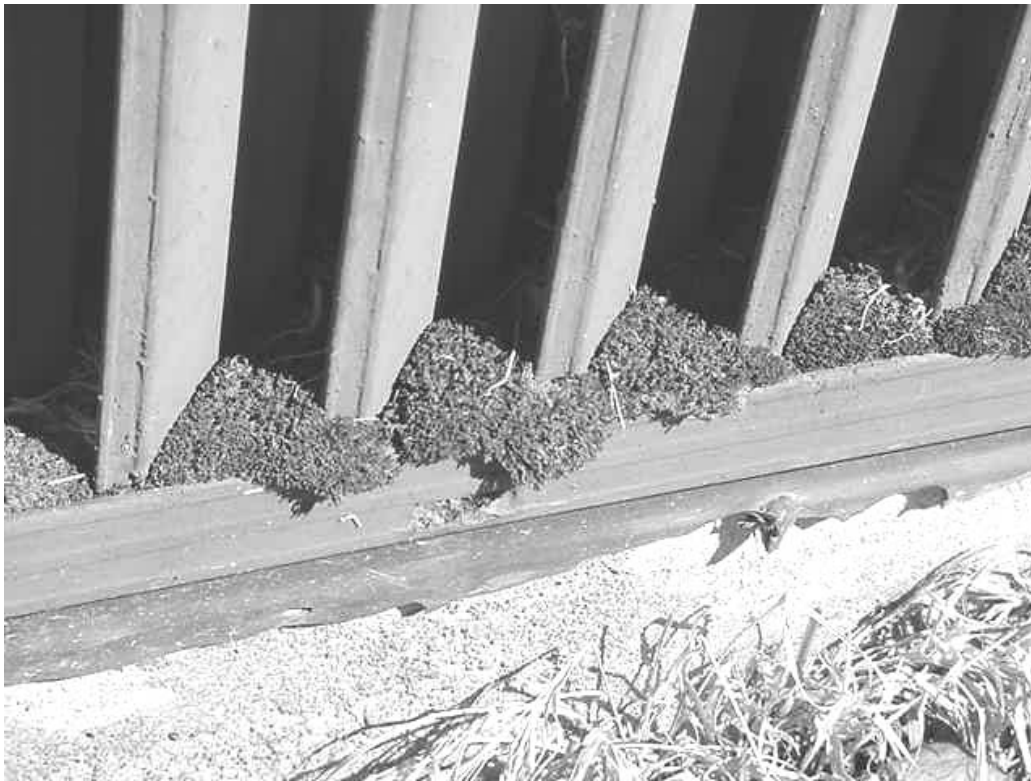
Picture 13

Moss growth was observed on the inner lip of univent air intakes (see Picture 13). The design of the fresh air intakes allow for water and debris accumulation inside the grilles, which can in turn be drawn into univents and distributed into occupied areas. In several areas around the building, small trees/stumps and other plants were growing against the foundation and clinging plants were noted on exterior walls (see Pictures 14 & 15). The growth of plants/roots against the exterior walls and along the foundation can bring moisture in contact with wall brick and eventually lead to cracks and/or fissures in the foundation below ground level. Clinging plants can cause water damage to brickwork by inserting tendrils into brick and mortar. Water can penetrate into the brick along the tendrils, which can subsequently freeze and thaw during the winter. This freezing/thawing action can weaken bricks and mortar, resulting in wall damage.

Moss Growth in Univent Fresh Air Intake (Exterior)

7. Examine the feasibility of replacing or modifying the exterior of univent fresh air intakes to prevent the accumulation of moss and debris.

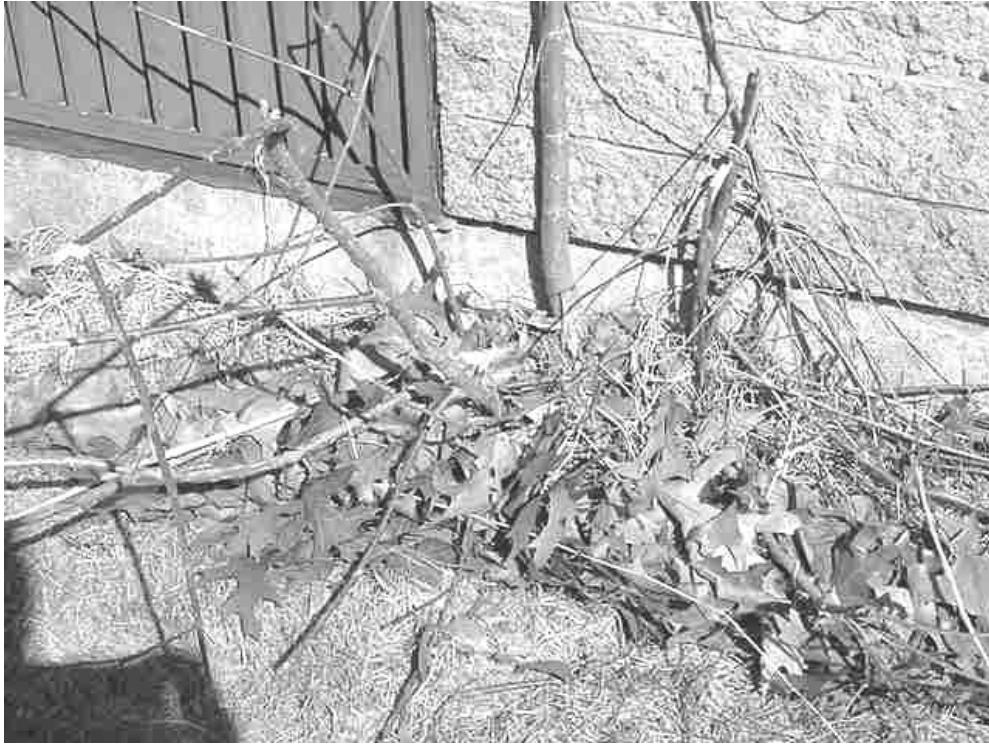
Picture 14

Small Trees/Roots Growing against the Foundation

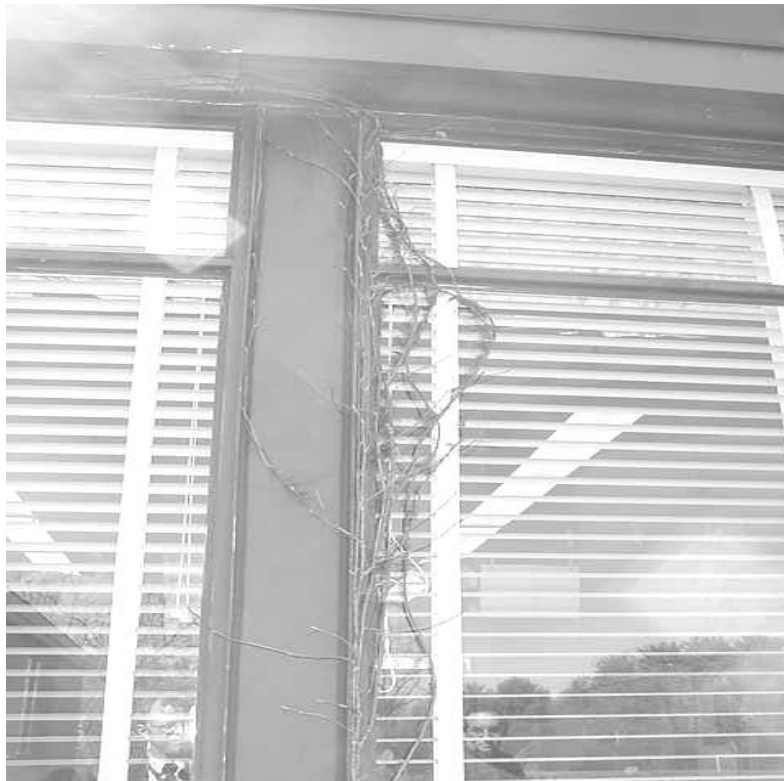
Picture 15

Clinging Plants on Exterior Wall

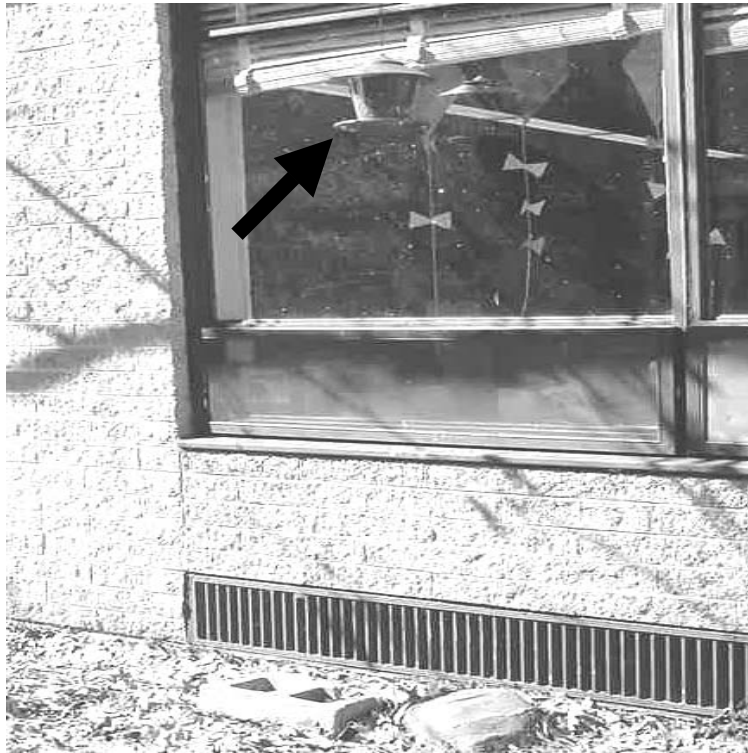
A bird feeder was mounted directly outside a classroom over the window and univent fresh air intake (see Picture 16). Accumulated bird waste was observed on the windowsill (see Picture 17). Birds can be a source of disease, and bird wastes and feathers can contain bacteria and fungi, which can be irritating to the respiratory system.

Bird Feeder Mounted over Window/Univent Air Intake

9. Relocate bird feeder in Picture 16 away from classroom window and univent air intake. Clean area of all bird wastes and disinfect with an appropriate antimicrobial.

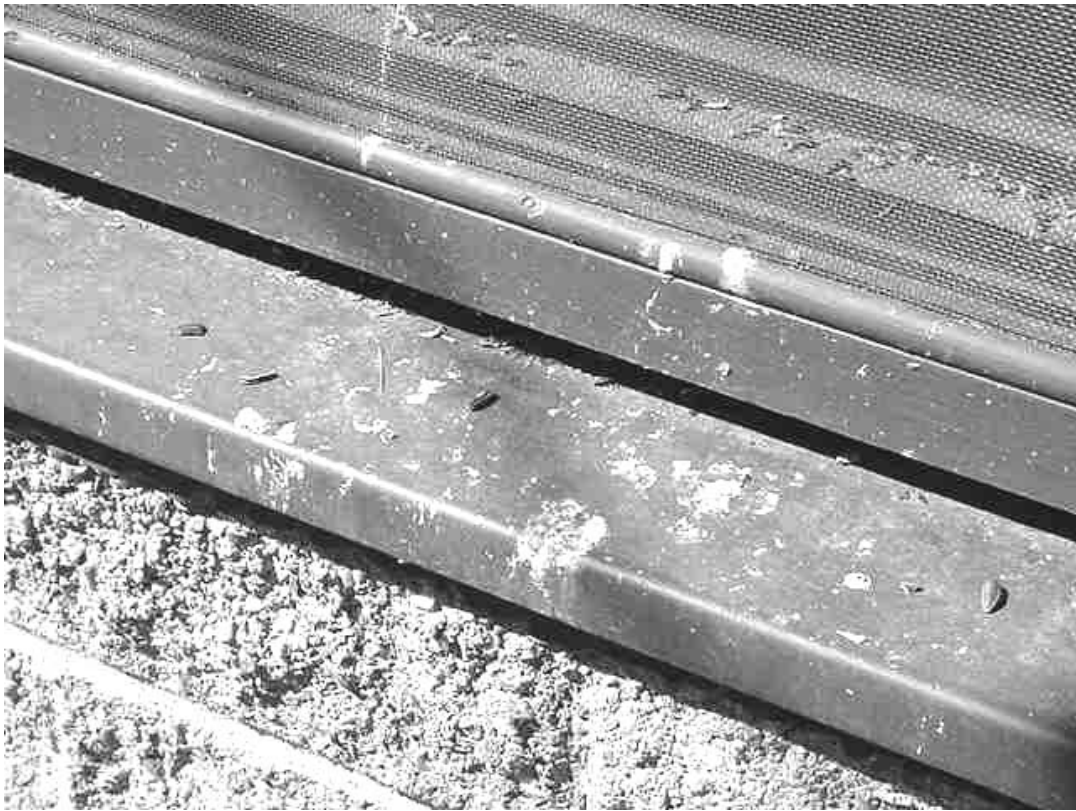
Picture 17

Bird Wastes on Classroom Windowsill (Beneath Bird Feeder in Preceding Picture)

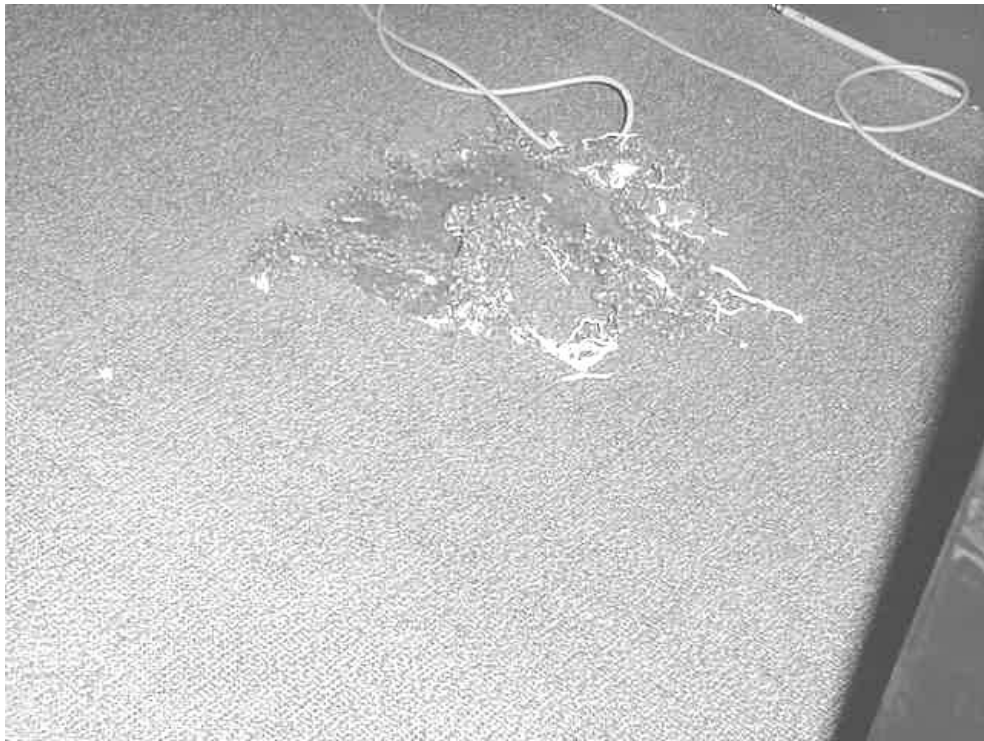
Picture 18

Carpeting in several areas was extremely worn and damaged (e.g. library and Principal's office) (see Picture 18). School staff reported that these carpets were installed during the original construction of the building, which would make them approximately thirty years old. Disintegrating textiles can be a source of particulates, which can be irritating to the eyes, nose and throat. Carpet fibers/particulate matter can be entrained and suspended in air by univents and/or AHUs.

Damaged/Worn Carpeting in Principal's Office

1. Based on the age, physical deterioration and availability of parts for ventilation components, the BEHA strongly recommends that an HVAC engineering firm fully evaluate the ventilation systems.
2. Consider replacing damaged/worn carpeting in the library and principal's office to prevent the aerosolization of carpet fibers.
3. Examine the feasibility of increasing mechanical supply and exhaust ventilation.
4. Contact an electrical engineer to reconfigure the control system so that univents and exhaust vents are controlled separately.
5. Examine the feasibility of installing a gutter/downspout system to parts of the building that lack them.
6. Contact an architectural/roofing firm to examine ways to prevent the accumulation and sliding of snowdrifts from the roof.
